Manhole Inspection Summary

Manhole # S25I__020MH

Location Address: **105 S. Carrollton Ave**

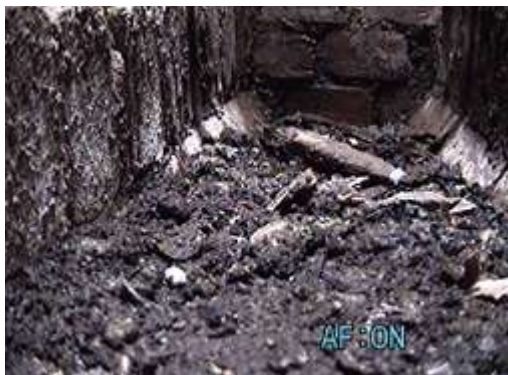
Defect 3

Condition: ☐ Sound ☐ Cracked ☐ Root Intrusion ☐ Deteriorated ☐ Leaks ☒ **Debris**

debris in channel

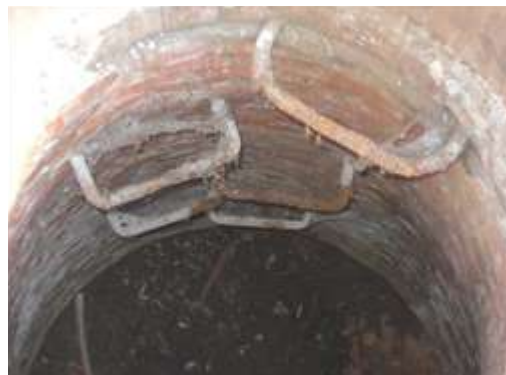
Defect 2

Condition: ☐ Sound ☐ Cracked ☐ Root Intrusion ☐ Deteriorated ☐ Leaks ☒ **Debris**

Steps Count: **5** Missing: **1** ☒ **Corroded**

corroded steps and Bench Debris

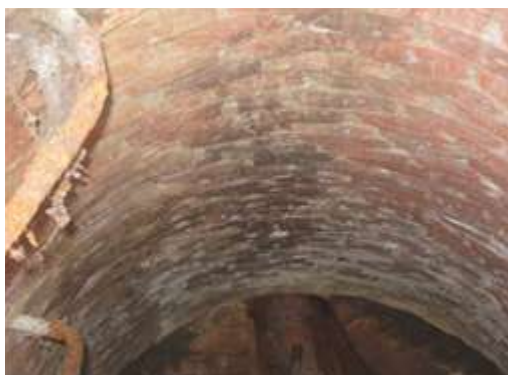
Defect 4

Infiltration: ☐ None ☐ Joint ☐ Cracks ☐ Mortar ☐ Roots ☒ **Wall**

infiltration along corbel wall

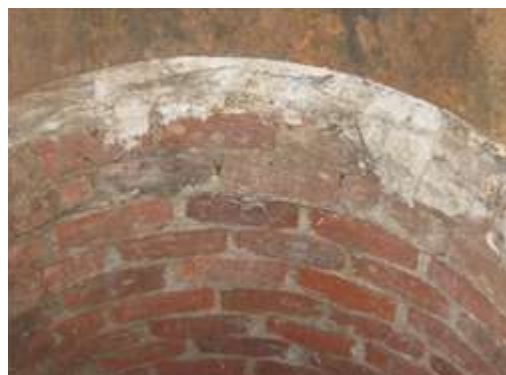
Defect 5

Condition: ☐ Sound ☒ **Cracked** ☐ Root Intrusion ☐ Loose Brick ☒ **Deteriorated**

Infiltration: ☐ None ☐ Joint ☐ Cracks ☐ Mortar ☐ Roots ☒ **Wall**

infiltration under frame, cracked, deteriorating chimney.

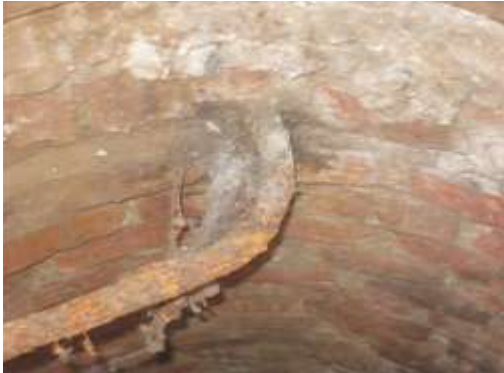
Defect 1

corroded steps infiltration from top

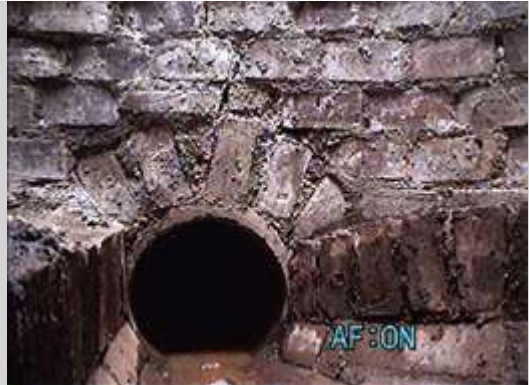
12 O'Clock Outflow

Pipe Height: **7.2** (in.) Rod and Bar (Angled)
Pipe Material: **Clay** ☐ Pipe Lined
Invert Depth: **9.90** (ft.) Flow Characteristics: **Slow**
Deposits: ☒ None ☐ Mud ☐ Sludge ☐ Debris ☐ Grease
Silt Depth: **0** (in.) Deposits Extent:
Infiltration: **None** Pipe Seal Cond: **Sound**

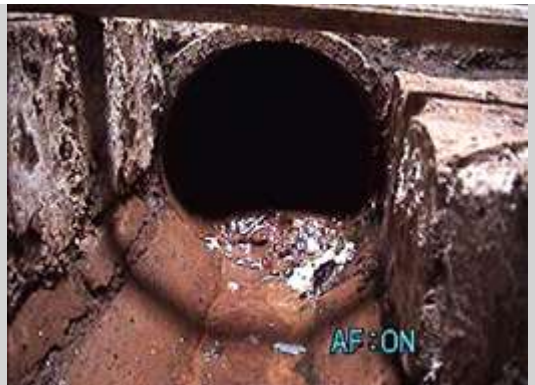
3 O'Clock Inflow

Pipe Height: **6** (in.) Rod and Bar (Angled)
Pipe Material: **Clay** ☐ Pipe Lined
Invert Depth: **9.40** (ft.) Flow Characteristics: **Slow**
Deposits: ☒ None ☐ Mud ☐ Sludge ☐ Debris ☐ Grease
Silt Depth: **0** (in.) Deposits Extent:
Infiltration: **None** Pipe Seal Cond: **Sound**
